LAKE ROLAND DAM

NDI I.D. NO. MD 104

PHASE I INSPECTION REPORT

Lake John D. Dam. (NDI I.D. Number MD-104)
Chesapeake Bay Basin, Jones Falls, Baltimore
County, Maryland

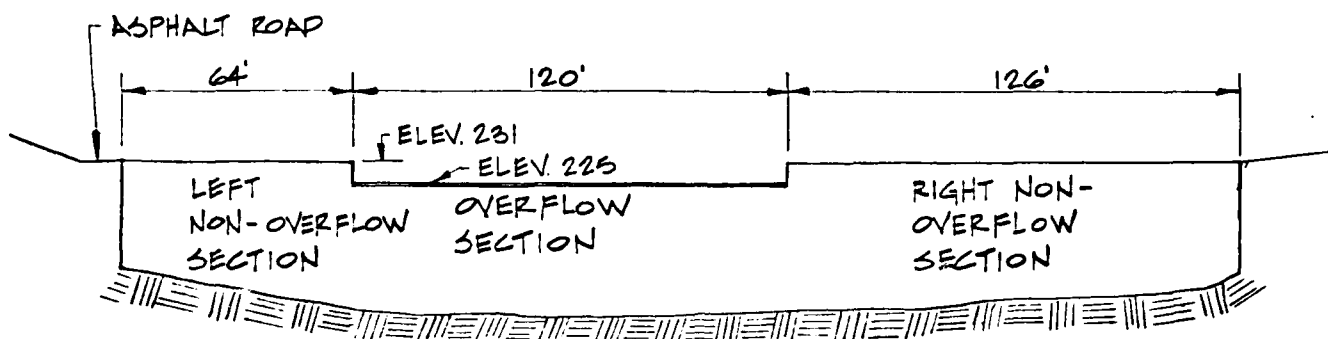
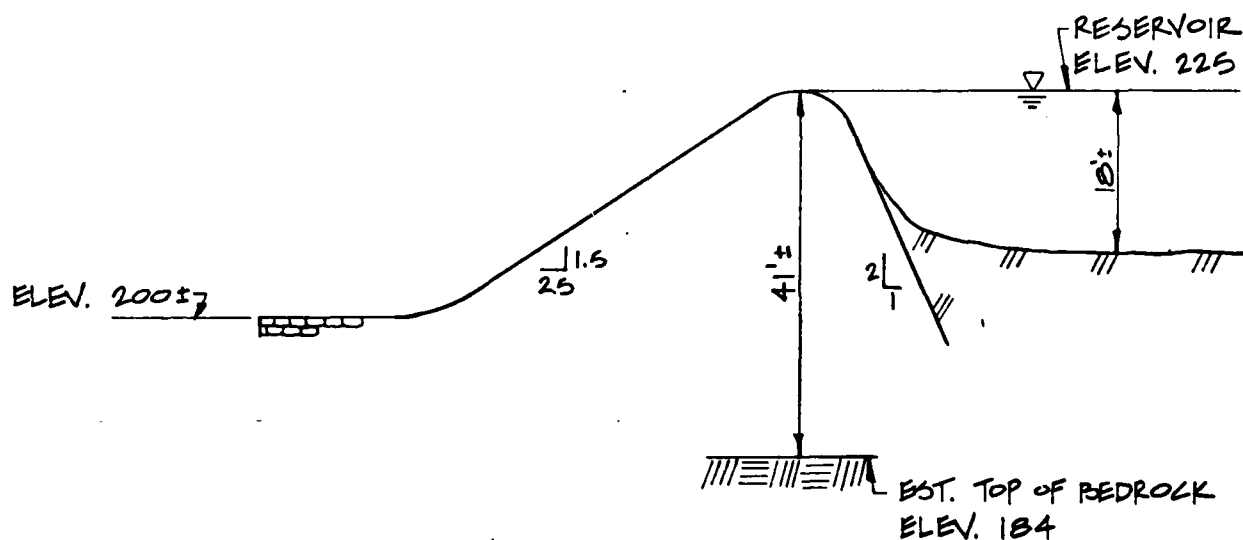
DATE: JULY 13, 1979		NATIONAL DAM INSPECTION PROGRAM	DAM CROSS SECTIONS
SCALE: AS SHOWN			
DR: JLM	CK: T.E.D.	ACKENHEIL & ASSOCIATES CONSULTING ENGINEERS BALTIMORE, MD.	
DWG. NO. 3

- 1) Non-overflow sections of the dam will fail before the overflow section. The overflow section is more massive in construction and has an estimated base width of 3 times the width of non-overflow sections. (See Drawing Nos. 3 and 4.)

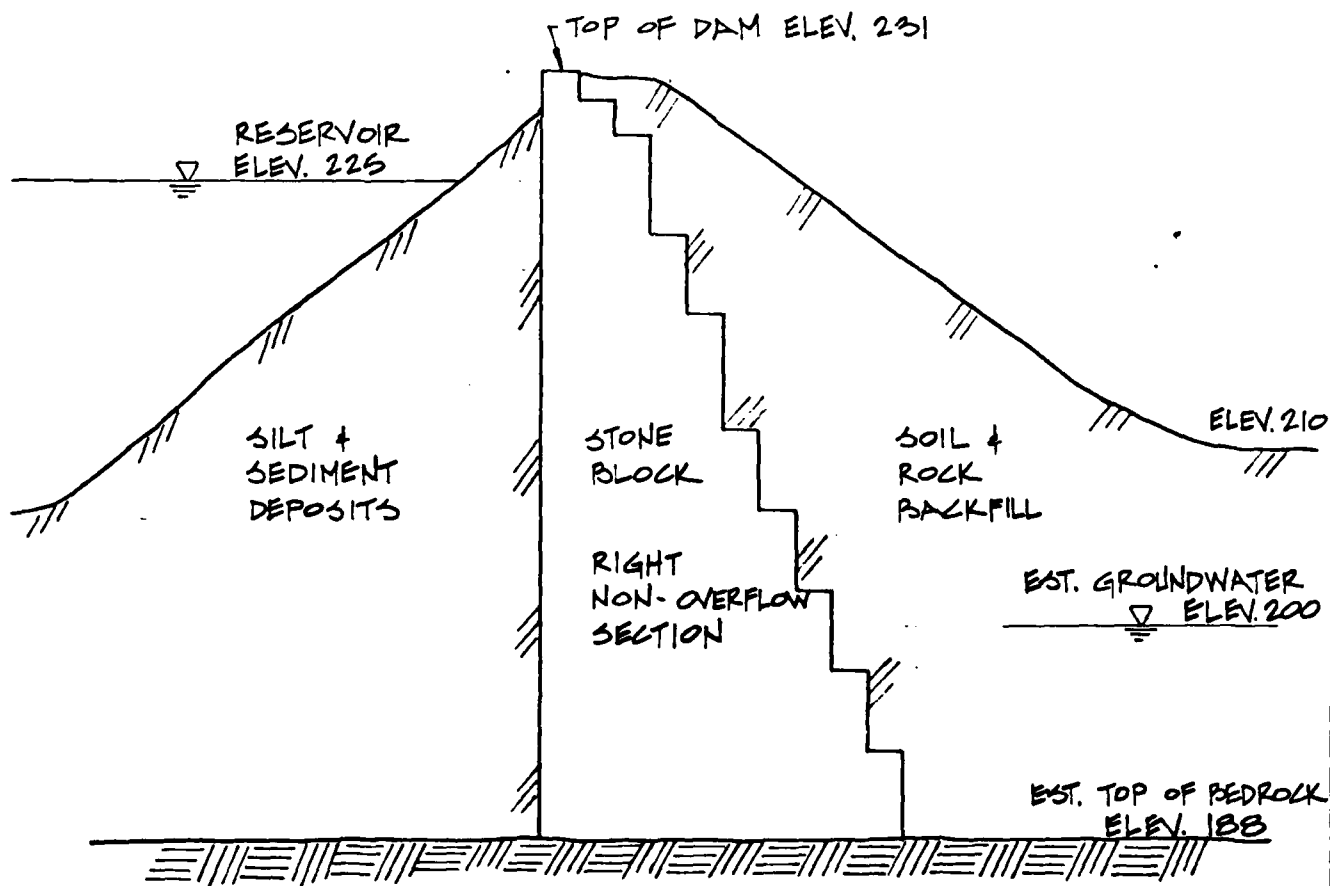
DATE: JULY 19, 1979		NATIONAL DAM INSPECTION PROGRAM	CROSS SECTION OF RIGHT NON- OVERFLOW DAM SECTION
SCALE: 1" = 10'			
DR: JLM	CK: T.E.D.	ACKENHEIL & ASSOCIATES CONSULTING ENGINEERS BALTIMORE, MD.	
DWG. NO. 4

Stability calculation results (presented in Section 6) indicate failure of the right (north) non-overflow section can be expected when overtopping flows reach about 5 ft. Failure was based on the assumption that downstream backfill cover of non-overflow sections will be eroded to about bedrock level (El. 188±). The 5 ft. overtopping required for failure approximately corresponds to a 35 percent PMF inflow, which was selected as the "failure" storm.
